**CRANE CO.
Hydro-Aire Inc.
& Lear Romec
Submission to the
National Transport Safety Board
TWA Flight 800 Investigation
DCA96MA070**

I Lear Romec Scavenge Pump

II Hydro-Aire Jettison/Override Pumps

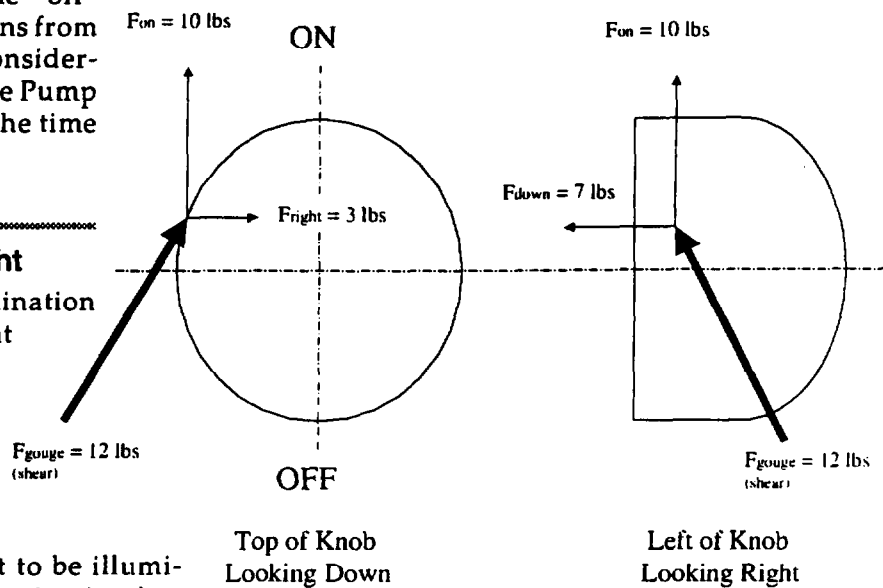
Figure 2 Gouge Force Diagram

Report WL/MLS 97-074 addresses the question of whether an impact to the scavenge pump switch knob, as evidenced by a gouge, resulted in a force toward the "OFF" direction.⁴ The conclusion drawn and evaluation presented in the factual report vector force diagram⁵ is based on the assumption that the impact between the knob and the striking object is a glancing collision, such as two pool balls striking each other. The gouge in the knob and associated displacement of metal is evidence that the switch was not forced toward the "OFF" direction. Consideration must be given to the direction and magnitude of the force to cause the gouge and the resultant reaction forces in the knob. **Figure 2** represents the force of the impact causing the gouge and shows the components of that force as related to switch operation. An estimated force of twelve pounds was required to cause the gouge. This results in approximately ten pounds of force in the "ON" direction and seven pounds of force along the toggle shaft preventing movement over the cam locking ring. Movement of the knob in the "ON" direction is blocked by the detent mechanism. Such an interaction also produces approximately a three pound force on the knob to the right while in the "OFF" position, consistent with the damage noted on the locking cam.⁶

support any forced movement to the "off" position by impact or some other means from the mishap breakup⁸, there is also considerable evidence to indicate the Scavenge Pump Switch was in the "OFF" position at the time of the accident.

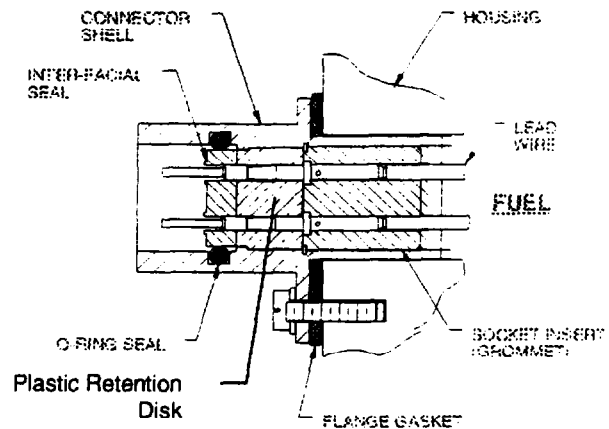
Figure 3 Electrical Connector Cross Section

During the investigation it was found that some scavenge pumps had electrical connectors installed during non-factory overhauls, that were made with an unqualified socket insert (grommet) material which can degrade with long-term fuel exposure. These findings gave rise to the desire to further evaluate the continued explosion proof capability of the scavenge pump and its leak tightness with the incorrect grommet material installed.

graded material was found in the scavenge pump obtained from an airline. After the tear-down inspection of the unit it was modified to incorporate a spark plug for the explosion proof testing, reassembled, and leak tested. The degraded connector passed the external leakage test. The Group conducted the explosion proof testing with the service unit that contained the degraded grommet material. The explosion was contained in the housing and the explosive atmosphere surrounding the test pump did not ignite.²³

In addition to the testing, "The [Group] design review found that the scavenge pump connector pins were held apart by a plastic contact retention disk and that if a fire were ignited by a short circuit at the connector, it would have to pass through the flame arrestor tubes and the check valve to reach the fuel tank. The wheel well also had been equipped with heat detectors. Soot and fire patterns were not found to emanate from the rear wing spar at the fuel pump mounting hole."²⁴

Crane Co. concurs with the evaluation. The connector grommet material issue was not a factor in the accident.
